North Coast Regional Water Quality Control Board

Subject: **Inspection Report for August 21, 2018, Warrant Inspection of Humboldt County APN: 214-142-008-000, 214-142-009-000 and 214-142-011-000**

File: Cannabis Program Inspections, Humboldt County, August 2018 HCSO Inspection, WDID 1B161040CHUM

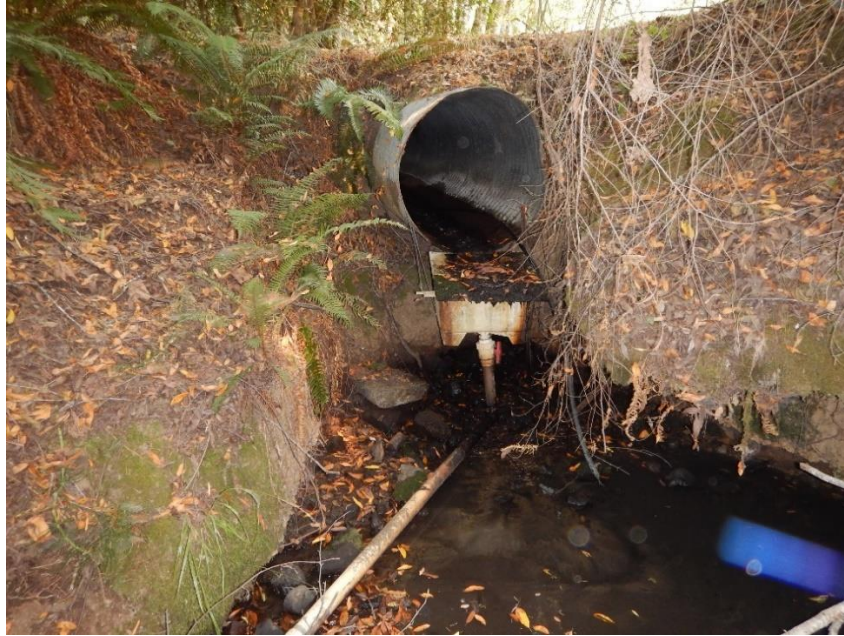
We approached the property from the west via a dirt road, entering near the southwest corner of parcel 214-142-009, and we inspected the culverted watercourse at map point 1, noting the presence of water diversion infrastructure below one of the culvert outlets (*photo 1*). We then inspected the pond south of this watercourse and another pond west, noting that the pond buttresses on both ponds appeared stable. Google earth imagery suggests these ponds were present as early as 1998. We followed water lines west of the westernmost pond on parcel 214-142-009 to a well, which is located along a dirt road that enters the parcel farther north than the road we had arrived on. We followed this road north and noticed spring-water pooling in a ditch on the westside of the road (*map point 2*) before flowing through a rusted culvert (*photo 2*) and discharging on the hillslope to the east above a pond (*photo 3*).

photo 1 – Stream diversion located a map point 1.

- 1) Remove water diversion infrastructure that is not associated with a valid water right.
- 2) Store and contain potting soils and fertilizers properly to prevent spillage and discharge to receiving waters. As a reference for the goal of this recommendation, review standard condition 7 of Regional Water Board Order No. R1-2015-0023 (Regional cannabis order) and relevant portions of the statewide cannabis order (CANGO).
- 3) Have a qualified professional identify and delineate all surface waters disturbed and/or buried through site development. This should include a forensic wetland delineation within and adjacent to all roads and cultivation areas.

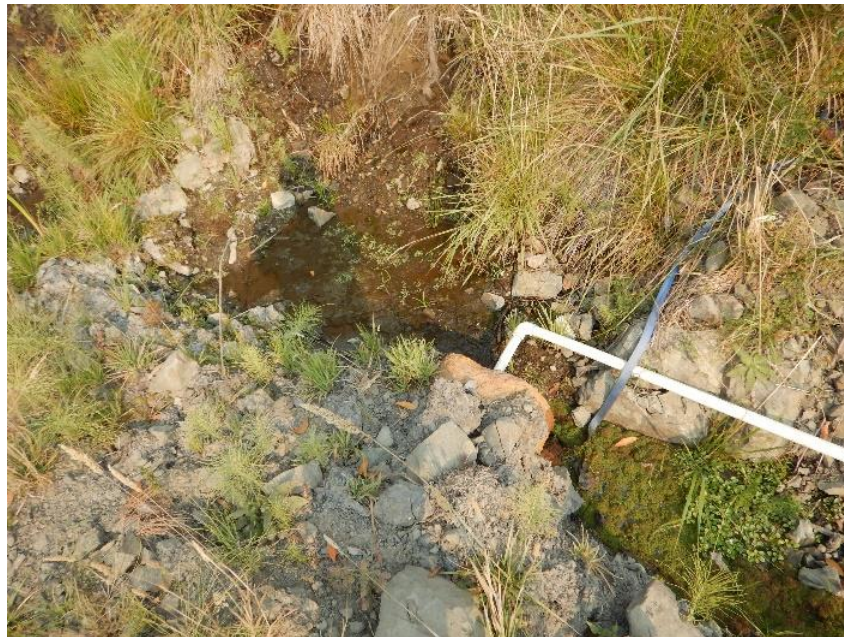
2. **Stream crossing maintenance and improvement:** The culvert capturing spring flow at map point 2 is rusted and partially crushed.

photo 2 – Culvert (*map point 2*) capturing spring flow originating northwest of the road and discharging somewhere on the hillslope (*photo 3*) above the pond to the southeast.

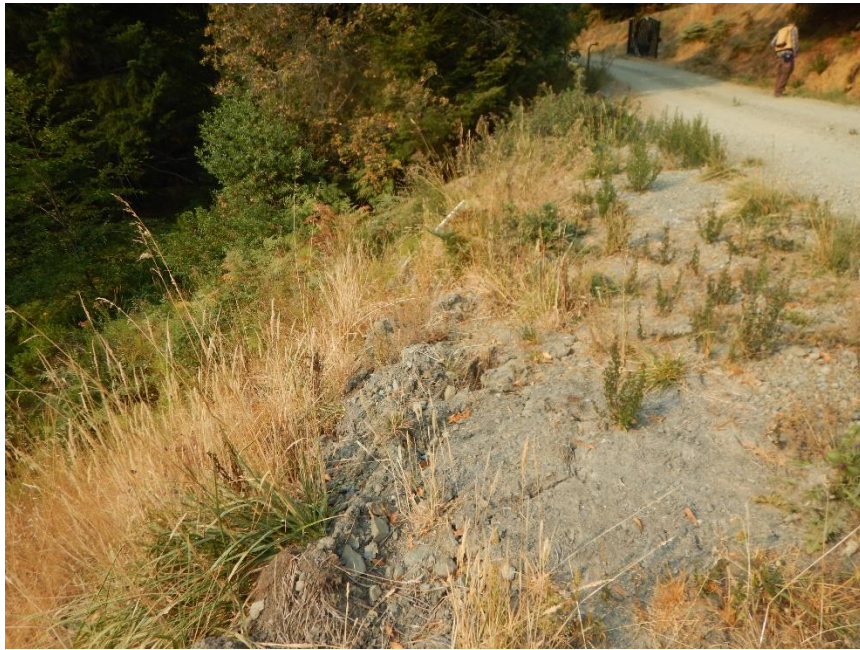
photo 3 – Approximate area where Culvert (*map point 2, photo 2*) discharges.

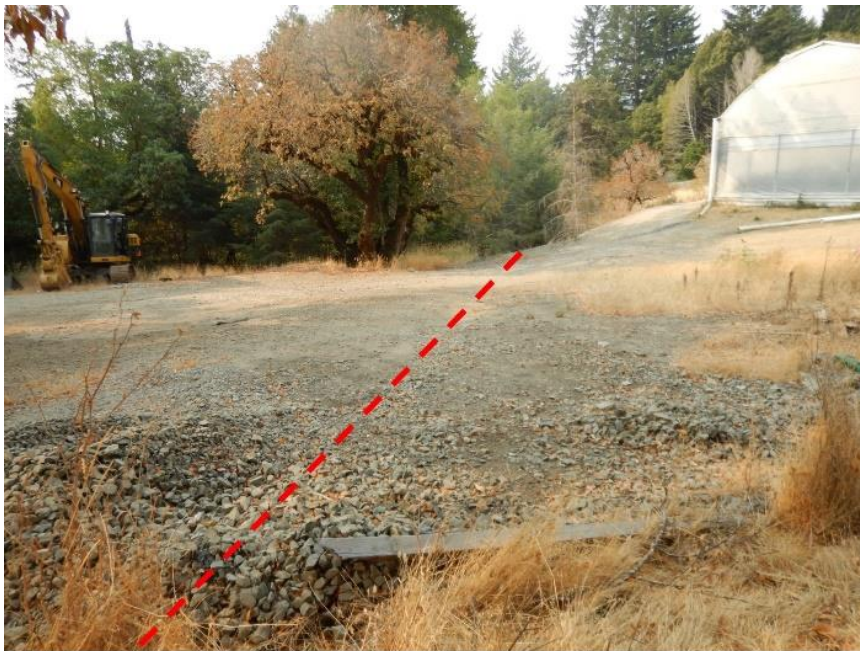
We continued following this road, noting that it was well rocked and appropriately shaped to shed stormwater, before arriving at Cultivation Area A. The east side of the graded flat area at this location covers a 160-foot length of a culverted watercourse (*photo 4 - 6*). We walked southeast towards a group of buildings and then headed northeast past a culverted stream crossing, incising downstream from the culvert. There was no apparent channel upstream from the road.

1. Site maintenance, erosion control and drainage features: Bare surface on east side of Cultivation Area A (*photo 4*) at map point 3 dips towards a watercourse, enabling stormwater to transport pollutants to receiving waters. The steep, unrocked road accessing Cultivation Area G is susceptible to erosion from stormwater.

photo 4 – East side of Cultivation Area A (*map point 3*), red line follows direction of watercourse culverted along a 160-foot length.

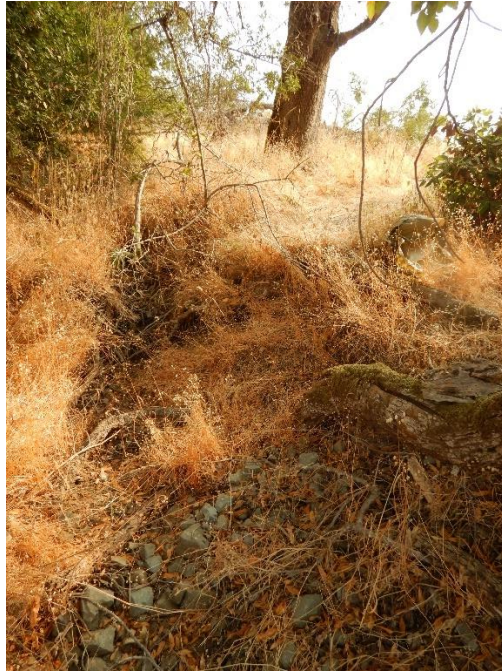
photo 5 – Watercourse upstream from culverted length pictured in photo 4.

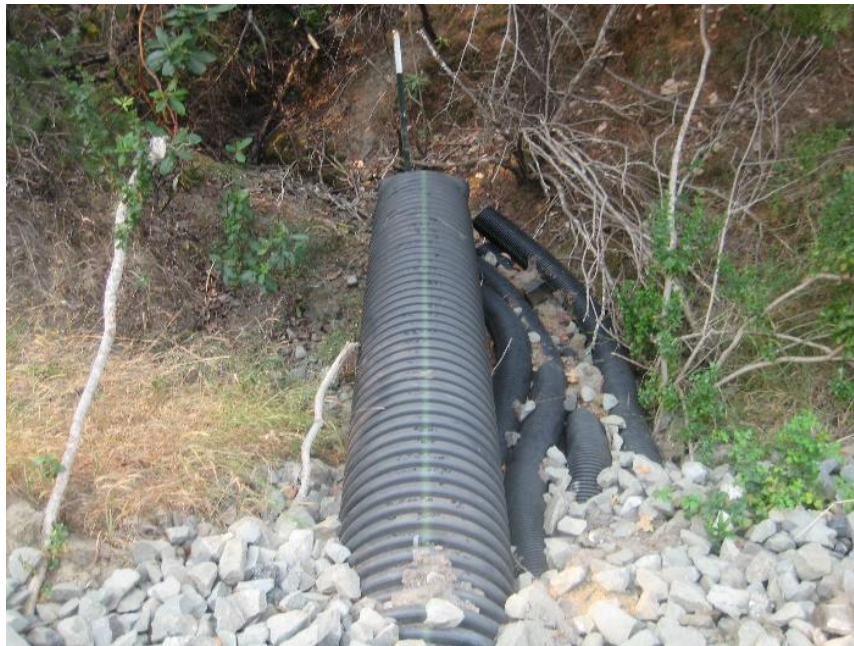
photo 6 – Watercourse downstream from culverted length pictured in photo 4.

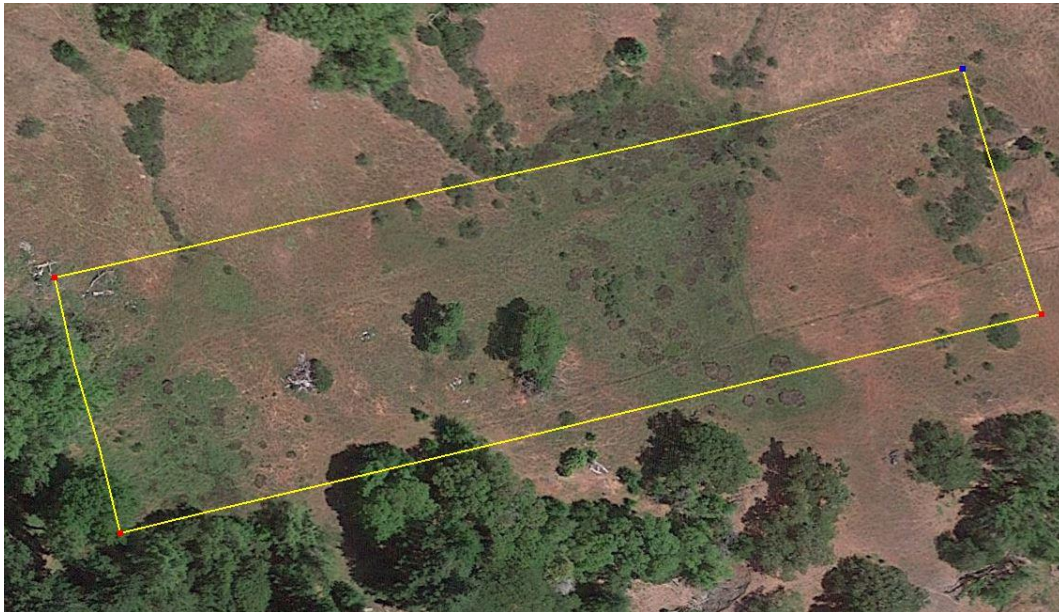
We continued along the road past the northern side of Cultivation Area B to an area with wetland indicating vegetation north of the road and a graded flat area south of the road (*photo 7*). Aerial imagery from 2014 (*photo 8*) and earlier suggests there was a wetland in this area prior to construction of the greenhouse (*photo 7 - 12*). Cultivation-related wastes were well contained inside the greenhouses, however, we observed potting soil stored uncovered outside where stormwater could transport it to surface water (*photo 13*).

photo 7 – Wetland apparent in 2014 aerial imagery. Yellow rectangle encompasses same 3-acre area displayed in photo 8 below.

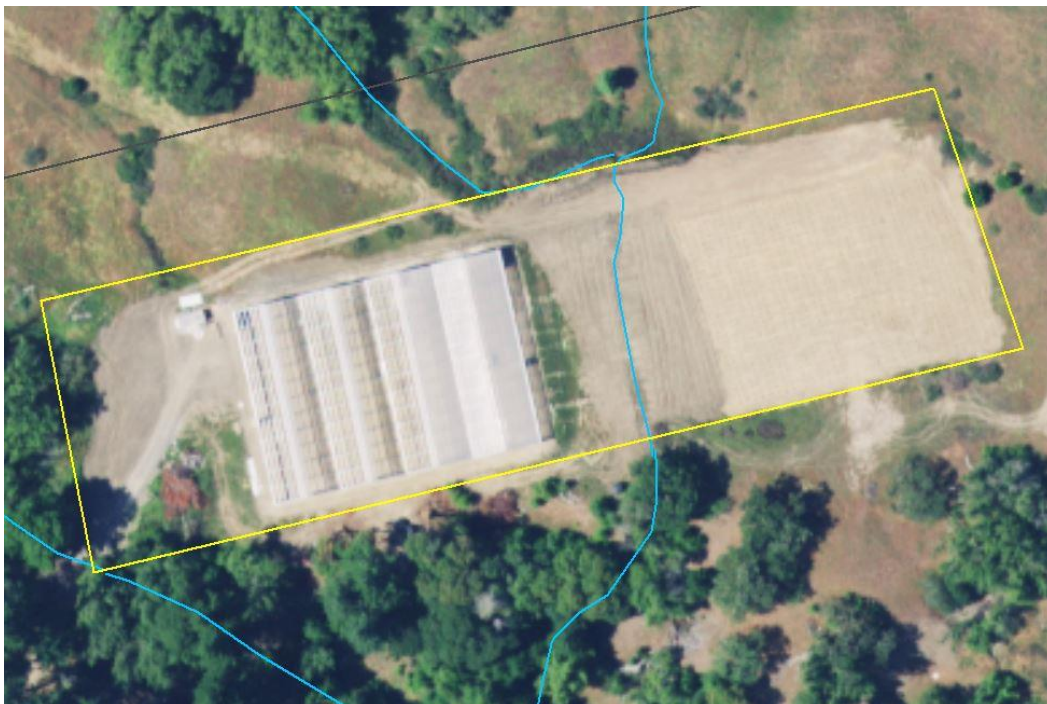
photo 8– Graded area apparent in 2016 NAIP imagery. Yellow rectangle encompasses same 3-acre area displayed in photo 7 above.

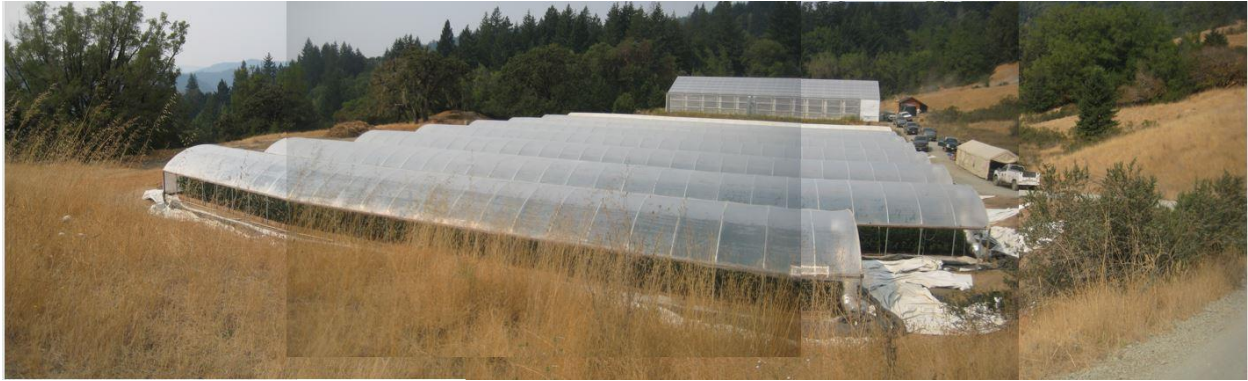
photo 9 – View looking west showing Cultivation Areas B and C displayed in photos 7 and 8 above.

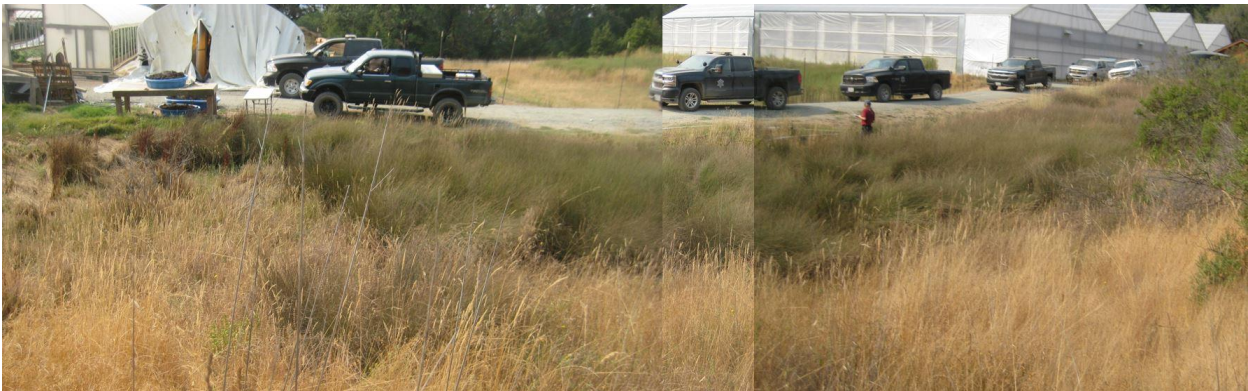
photo 10 – View looking south showing Cultivation Areas B to the right of image and Cultivation Area C to the left of image. The foreground of the image shows an area with wetland indicating vegetation; water flows from this area, through a culvert below the road, along a straight channel pictured in photo 11, and into an incising channel (*photo 12*) south of the graded area.

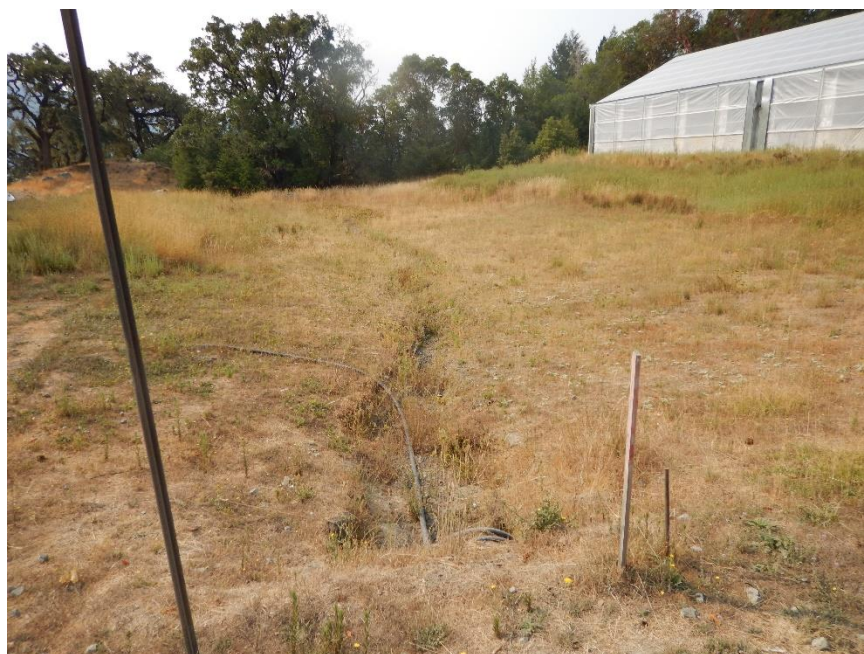
photo 11 – Straight channel between Cultivation Area B and C.

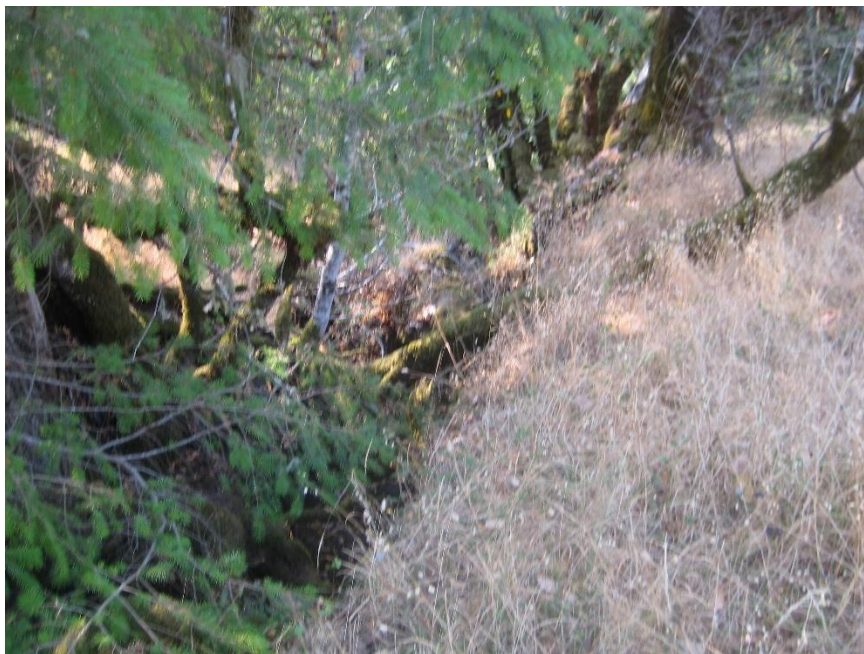
photo 12 – Incised channel south of Cultivation Areas B and C.

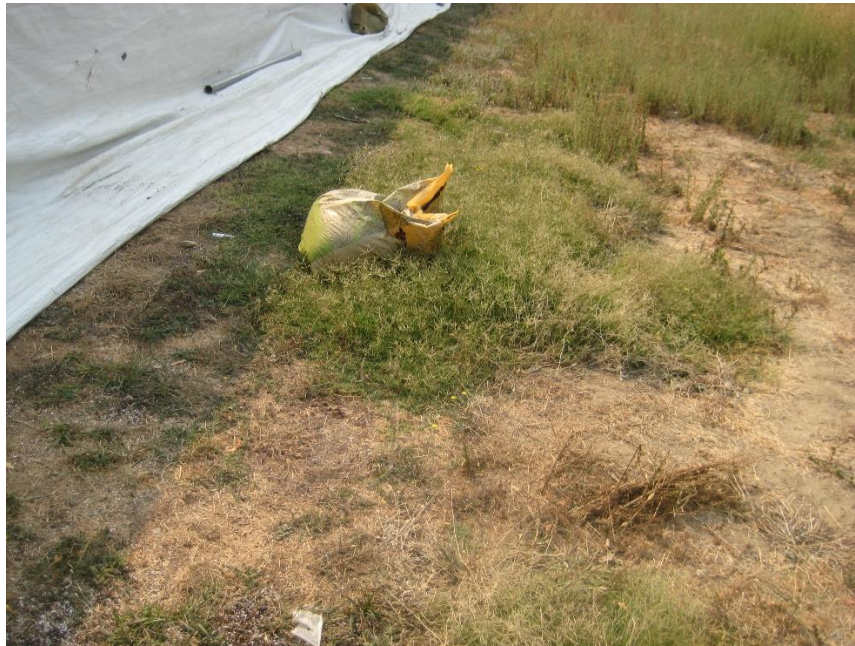
4. **Spoils management:** We observed uncovered potting soil on bare ground within 50 feet of the watercourse between Cultivation Areas B and C.

photo 13 – Bag of potting soil stored uncovered on bare ground within 50 feet of watercourse between Cultivation Areas B and C.

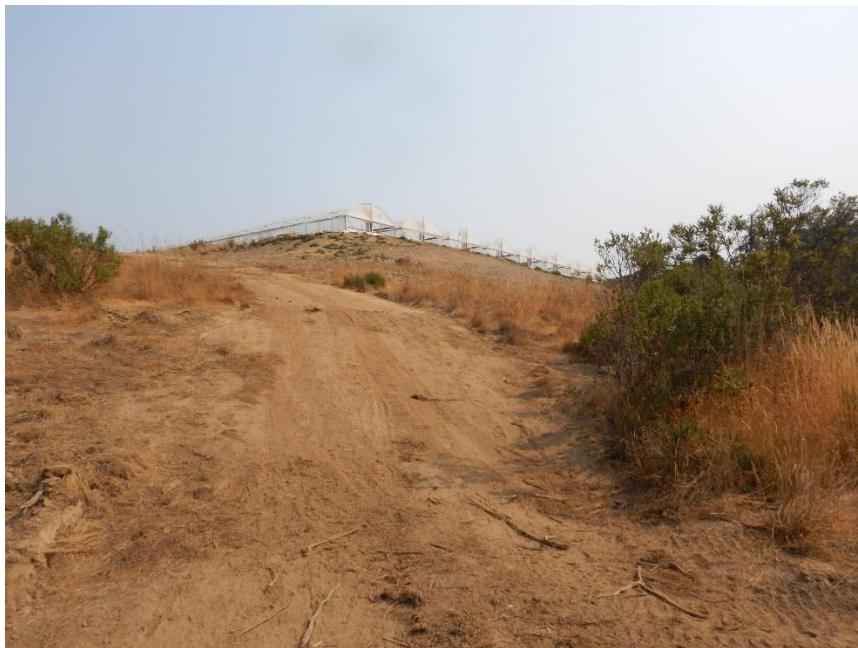
We continued east of Cultivation Area C to Cultivation Area G, and observed a steep, un-rocked road that is susceptible to erosion from stormwater (*photo 14*). We then continued east to Cultivation Area F, where we did not observe any water quality concerns and then returned west past an unoccupied residence where CDFW Warden Zulliger discovered a copy of the Water Resource Protection Plan (WRPP) for the site, prepared by Timberland Resource Consultants on October 26, 2016. After reviewing the WRPP, we continued west, inspecting three more ponds. The first pond was south of the road, 250 feet west of the unoccupied house; the second was north of the road, 800 feet west of the unoccupied house; and the third is the pond which receives drainage from the failing culvert identified in photos 2 and 3, 0.25 miles from the unoccupied house. Google Earth imagery suggests these ponds were present as early as 1998. I did not identify water quality concerns with any of these ponds. We then returned to the vehicles walking past the west side of Cultivation Area A.

photo 14 – View looking north towards the southwest corner of Cultivation Area G. The steep, unrocked road is susceptible to erosion from stormwater.

- 4) Develop a workplan and schedule to implement measures to ensure that all developed features and cultivation areas throughout the Property are corrected, restored, and/or maintained in conditions that prevent or minimize erosion, sediment transport/delivery, and adverse impacts to water quality and beneficial uses. This work should include restoring any buried /filled watercourses and/or wetlands, providing compensatory mitigation for impacts to function and value of affected surface waters, disposing of associated spoils in a location and manner to prevent transport/delivery into surface waters, and a revegetation and monitoring plan.
